Manhole Inspection Summary

Manhole # S25C1_012MH

Location Address: **2715 MAISEL ST.**

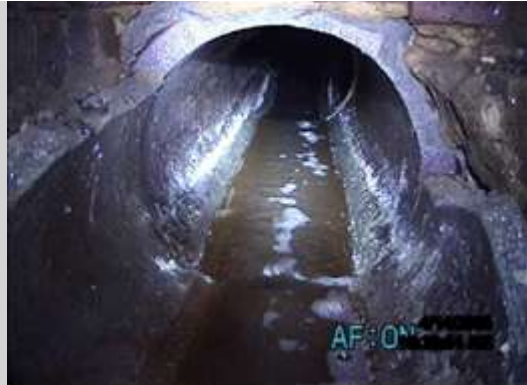
12 O'Clock Outflow

Pipe Height: **12** (in.) Rod and Bar (Angled)
Pipe Material: **Clay** ☐ Pipe Lined
Invert Depth: **14.44** (ft.) Flow Characteristics: **Slow**
Deposits: ☒ None ☐ Mud ☐ Sludge ☐ Debris ☐ Grease
Silt Depth: **0** (in.) Deposits Extent:
Infiltration: **None** Pipe Seal Cond: **Unknown**

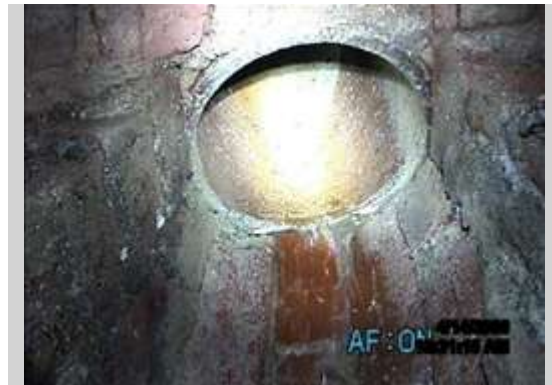
Drop In @ 3 O'Clock

Drop: **Outside** Rod and Bar
Angled: **Yes** Reading: **12.92** (ft.)
Inv Depth: **13.92** (ft.)
Drop Condition: **Open**
